Manhole Inspection Summary

Manhole # S590__003MH

Insp Date: **12/29/08 11:45 AM**

Location Address: **4232 boston**

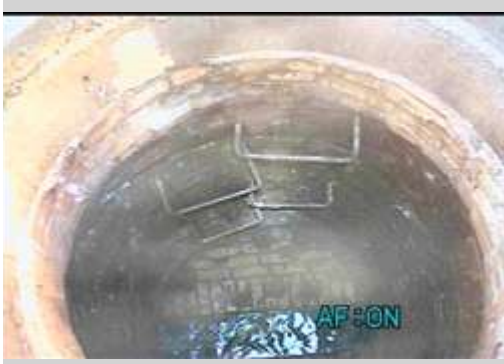
Defect 1

Steps Count: **4** Missing: **0** ☒ **Corroded**

steps

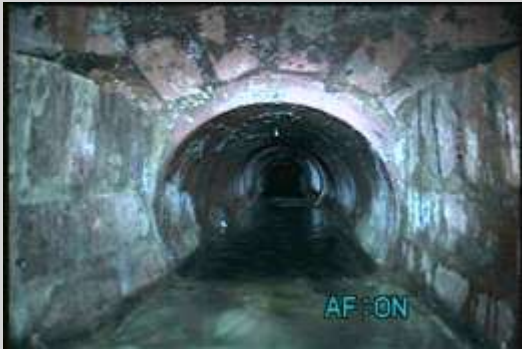
12 O'Clock Outflow

12 in. Circular Gravity Sewer
Pipe Out @ 12 O'Clock

Pipe Material: **Clay** ☒ Pipe Lined

Infiltration: **None** Pipe Seal Cond: **Unknown**

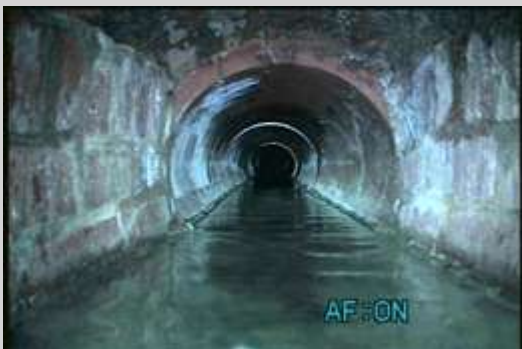
6 O'Clock Inflow

12 in. Circular Gravity Sewer
Pipe In @ 6 O'Clock

Pipe Material: **Clay** ☒ Pipe Lined

Infiltration: **None** Pipe Seal Cond: **Unknown**
